MEMORANDUM

Re: Post-TCRA Visual Inspection Report – April 2015

This document reports the results of the April 2015 visual inspection of the armored cap cover, fencing, and signage installed for the Time Critical Removal Action (TCRA) at the San Jacinto River Waste Pits Superfund Site (TCRA Site).

INSPECTION PHOTOGRAPHIC LOG

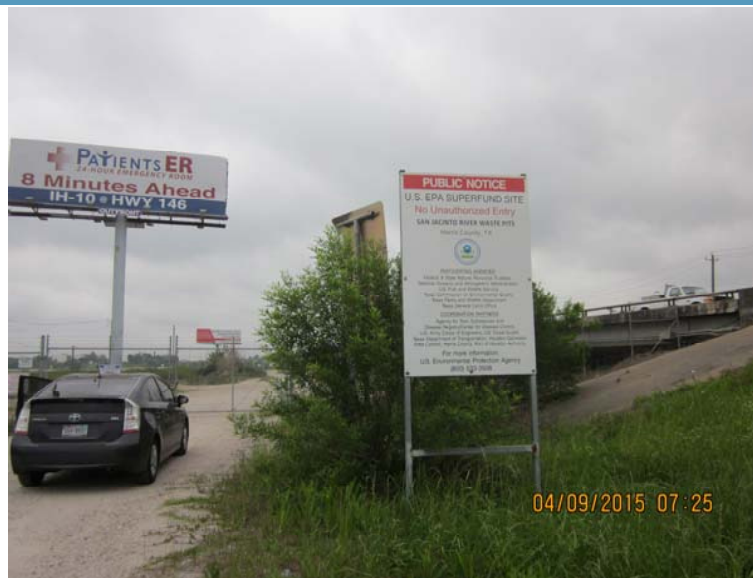
Three USEPA Public Notice signs are present around the TCRA Site located: 1) near the gate entry point for the perimeter fence north of I-10; 2) near a gate entry point south of I-10; and 3) at the end of the TxDOT right-of-way north of I-10 near the San Jacinto River. For examples, see Photographs 1, 7, and 14 in Appendix A. These three signs were observed to be in place and undamaged.

Photograph 01: USEPA public notice sign located outside the access gate north of I-10 (view east)

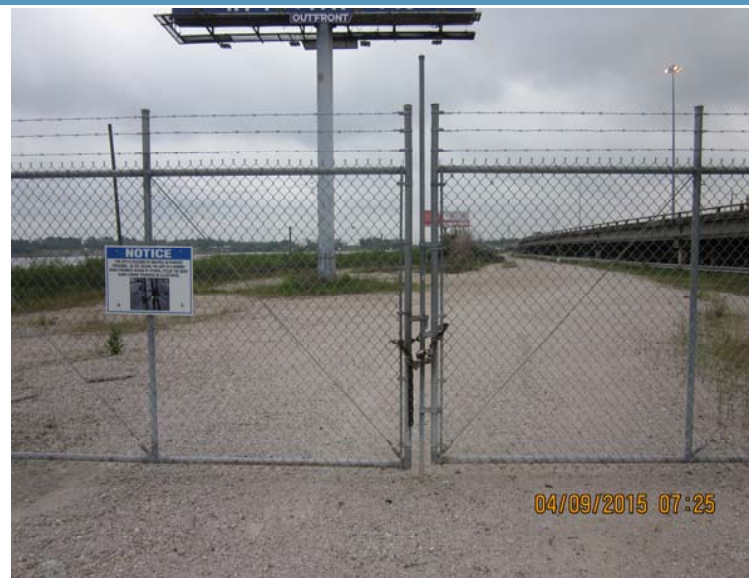
Signage on all locked gates reminds entrants to “daisy chain” the locks properly prior to leaving the TCRA Site. For an example, see Photograph 2 in Appendix A. These signs were observed to be in place and undamaged.

Photograph 02: Access gate and "daisy chain" locking method notice north of I-10 (view east)

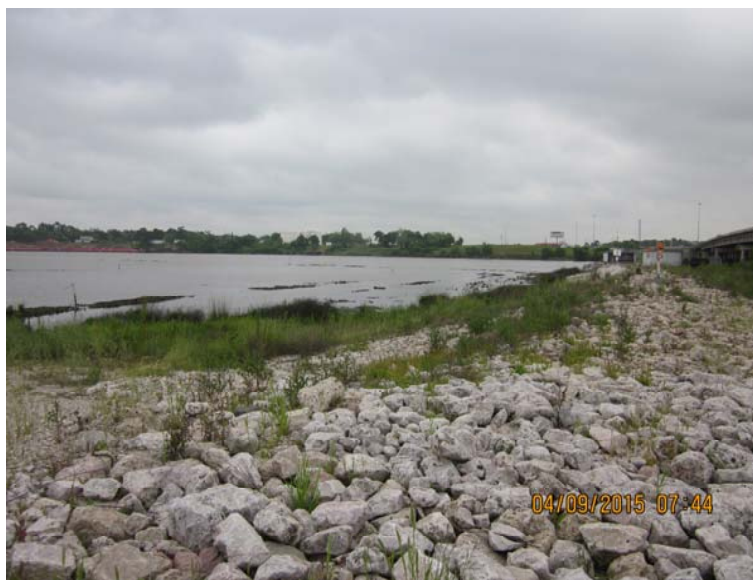
Photographs of the armored cap from the inspection event are provided in Appendix A (see Photographs 3 through 10). Due to a high tide, the majority of the Eastern Cell armored cap was underwater. All of the visible portions of the armored cap were observed to be intact, and no movement of cap materials was observed at any location during the visual inspection. Grassy and occasionally woody vegetation was observed around much of the armored cap perimeter.

A total of fifteen signs were installed at the TCRA Site around the perimeter of the land portion of the TCRA Site; the signs are mounted on steel posts and set in concrete pads. For examples, see Photographs 3 through 7, 9, and 10 in Appendix A. These signs are intended to face the San Jacinto River to deter water-based entry to the TCRA Site. A few of these signs had rotated out of proper alignment due to the wind; the affected signs were re-aligned to the intended viewing perspective.

Photograph 03: Warning signs and vegetation along southern berm (view east)

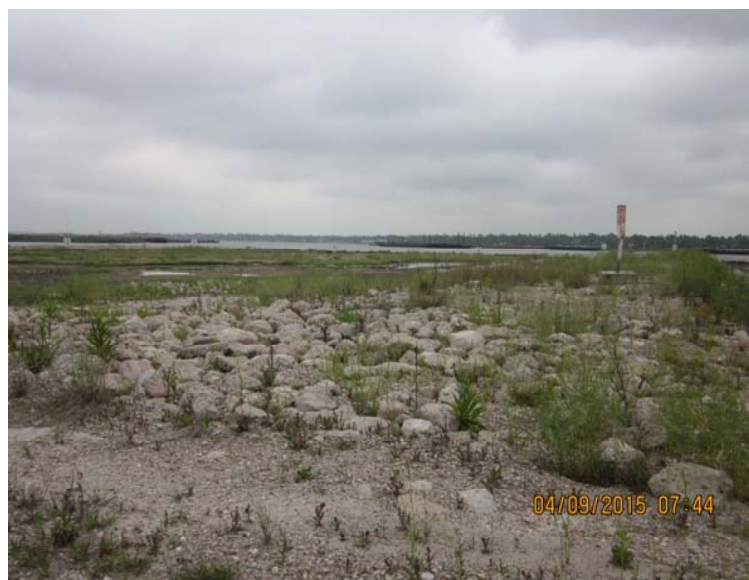
Photograph 04: Western Cell (view northwest)

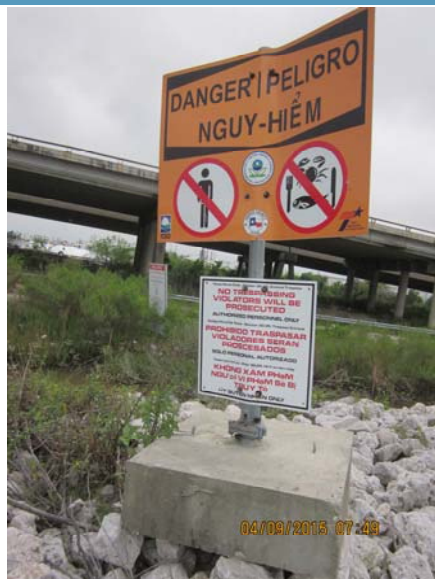
Photograph 05: Warning sign and USEPA public notice sign located at eastern edge of southern berm (view southwest)

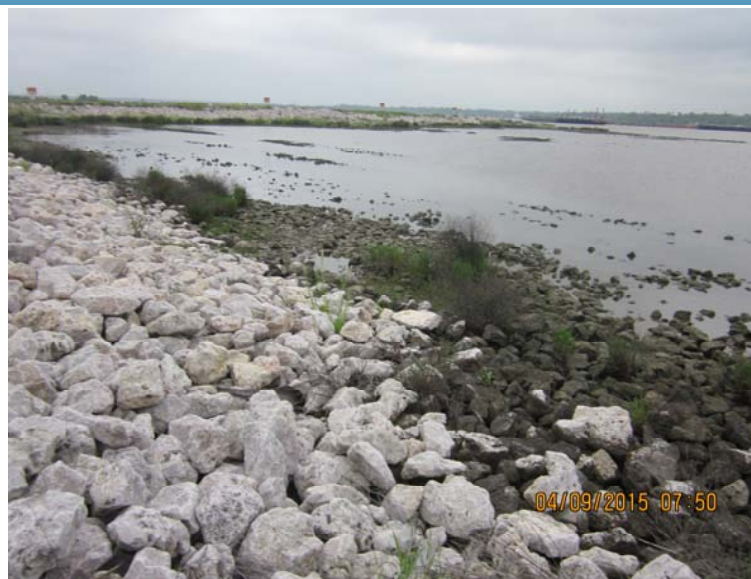
Photograph 06: Southern berm and Eastern Cell (view northwest)

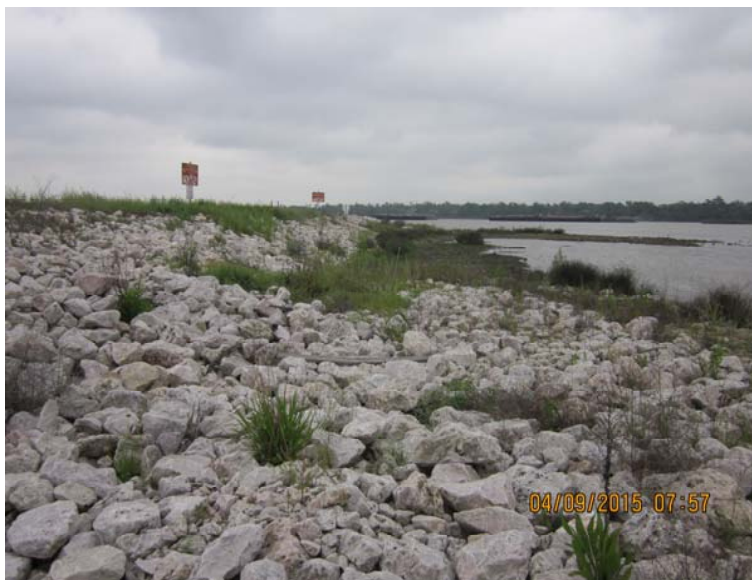
Photograph 07: Warning signs along central berm (view north)

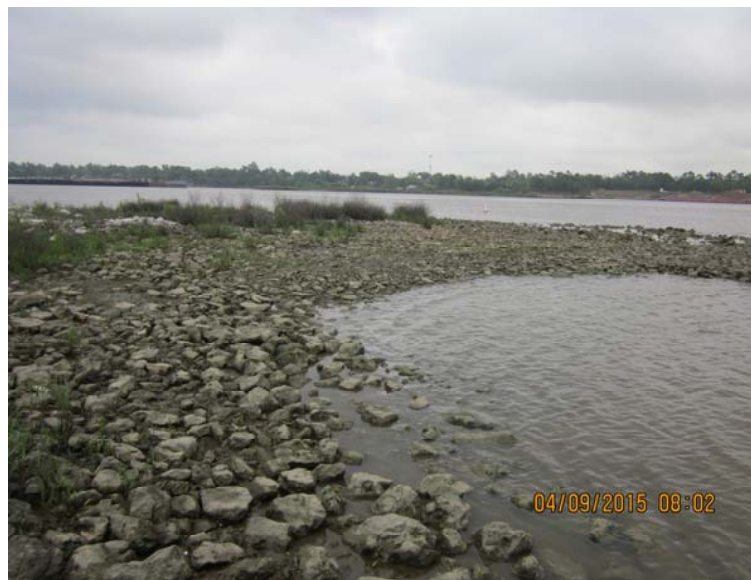
Photograph 08: Eastern Cell and warning buoy along the perimeter (view northeast)

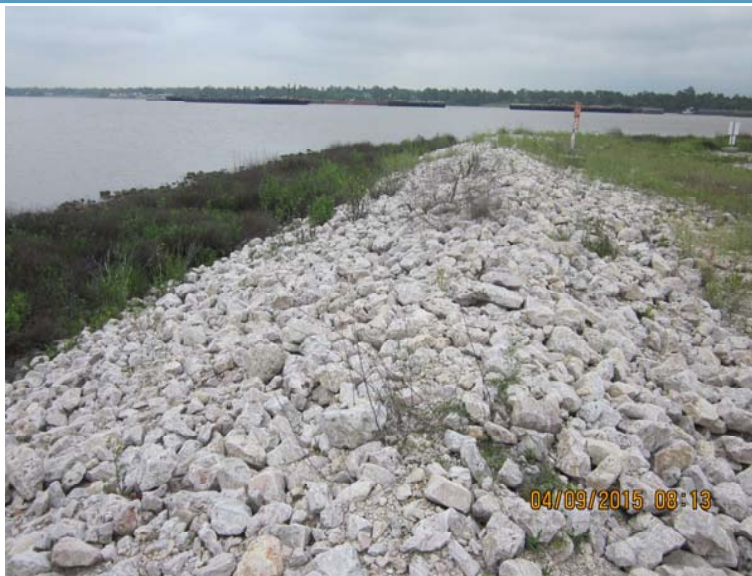
Photograph 09: Warning sign and vegetation along western berm (view north)

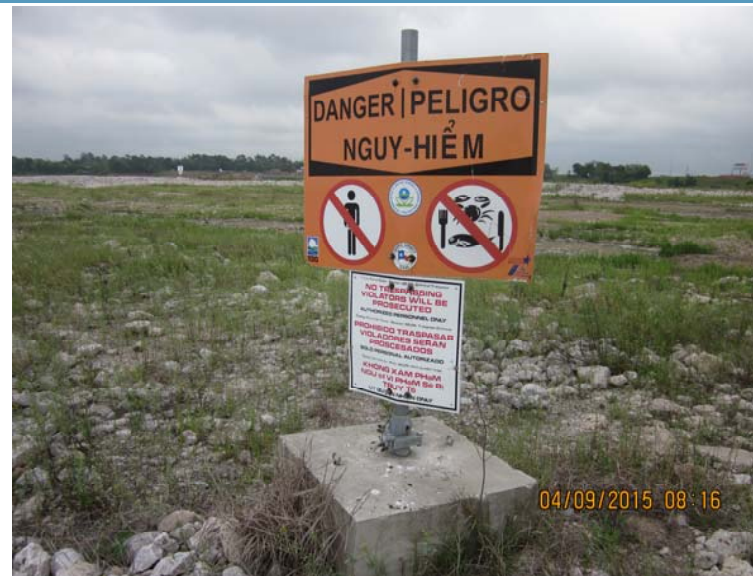
Photograph 10: Warning sign along western berm (view east)

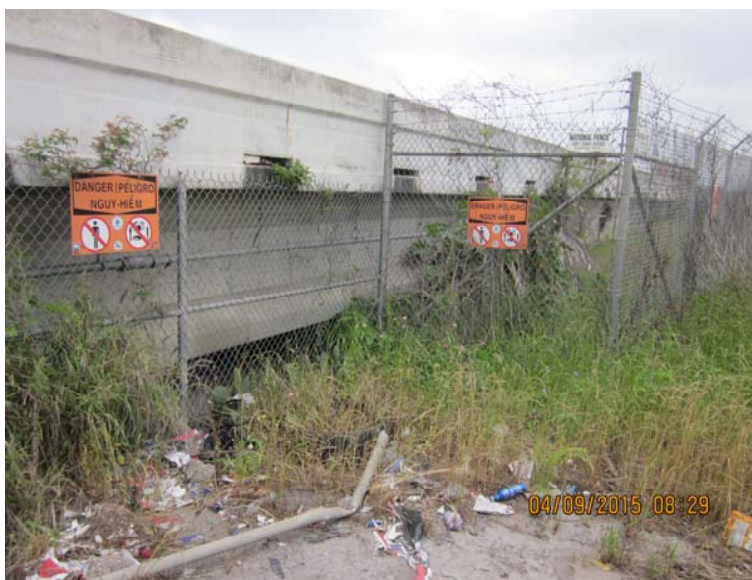
The perimeter fencing on the west and east banks of the San Jacinto River was visually inspected for breaches or other signs of damage. No breaches or other signs of fence damage were observed during the inspection for any of the three sections of the fence: the east bank, the west bank on the north side of I-10, or the west bank on the south side of I-10. For examples, see Photographs 1, 2, 11 through 14, and 16 in Appendix A.

“Danger” and “No Trespassing” signs are posted at regular intervals on the perimeter fencing surrounding the TCRA Site. For examples, see Photographs 11 through 13 in Appendix A. These signs were observed to be in place during the April 9, 2015 inspection.

Photograph 11: Signage and perimeter fencing south of I-10 on west bank (view northeast)

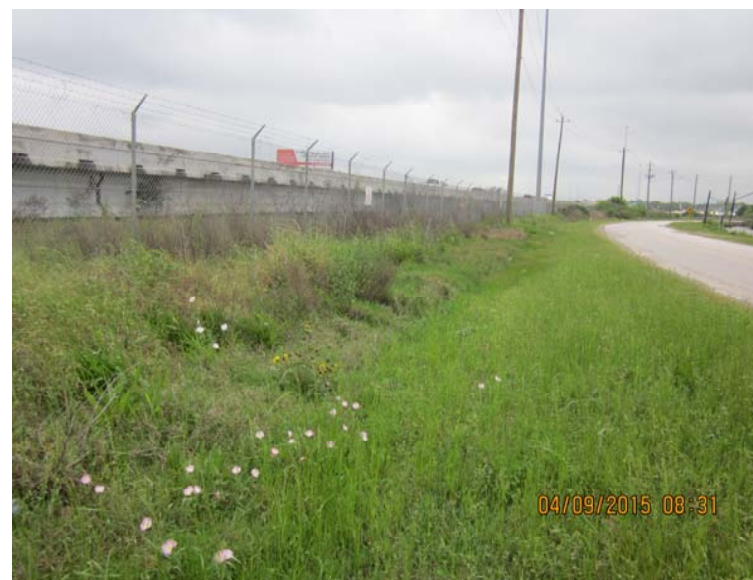
Photograph 12: Signage and perimeter fencing south of I-10 on west bank (view northeast)

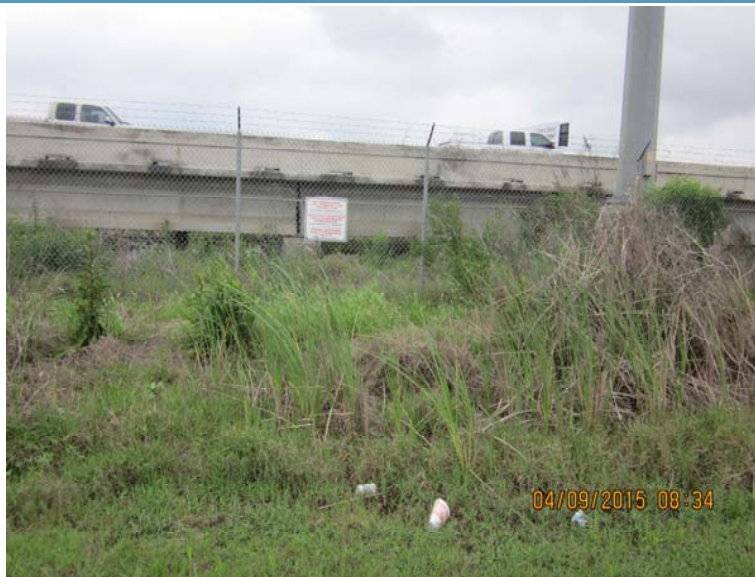
Photograph 13: Signage and perimeter fencing south of I-10 on west bank (view north)

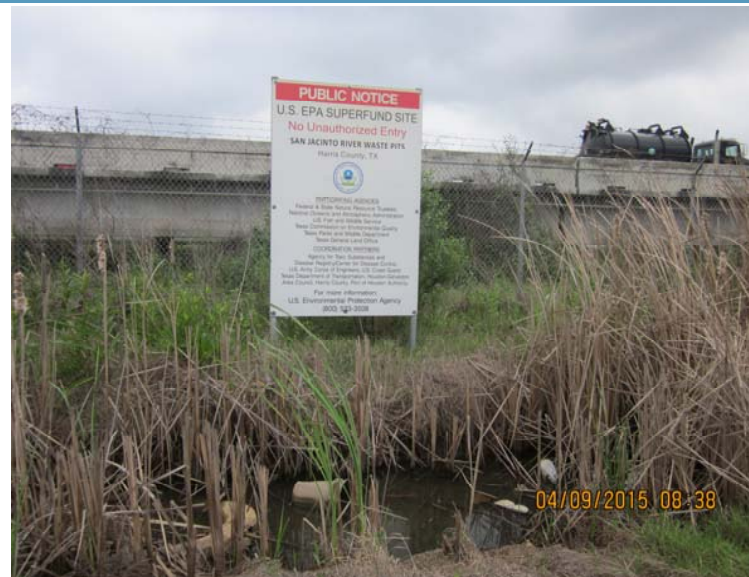
Photograph 14: USEPA public notice sign located south of I-10 (view north)

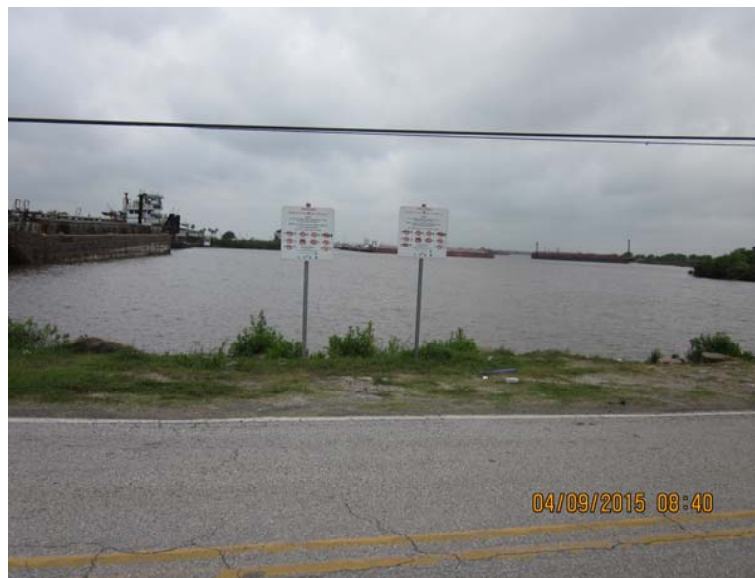
Photograph 15: Fish consumption advisory signs south of I-10 on west bank (view south)

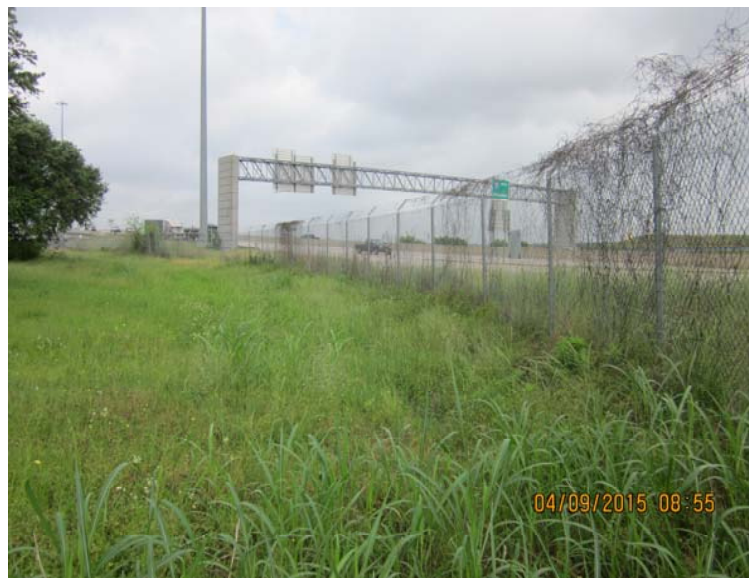
Photograph 16: Perimeter fencing south of I-10 on east bank (view northwest)

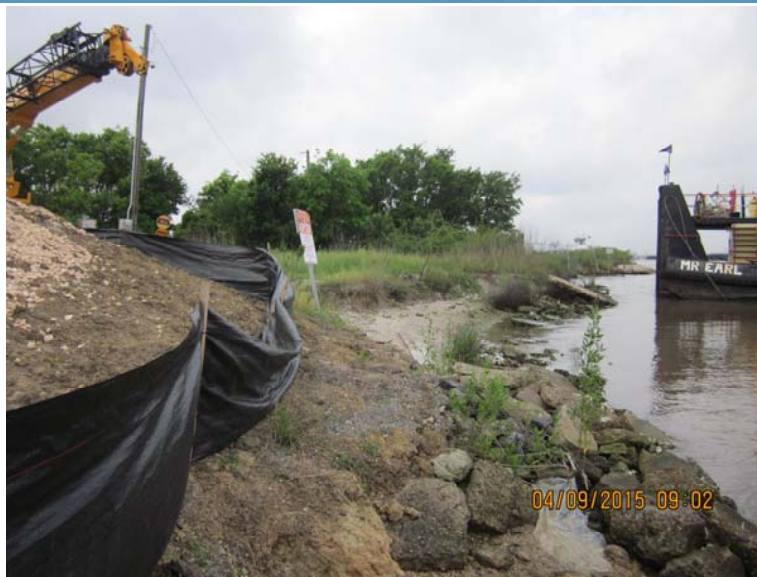
Photograph 17: Warning sign south of I-10 on east bank (view south)
